# Teton Basin Beaver Inventory

Summer of 2000

Prepared By: Derek Blandford

The Caribou Targhee National Forest

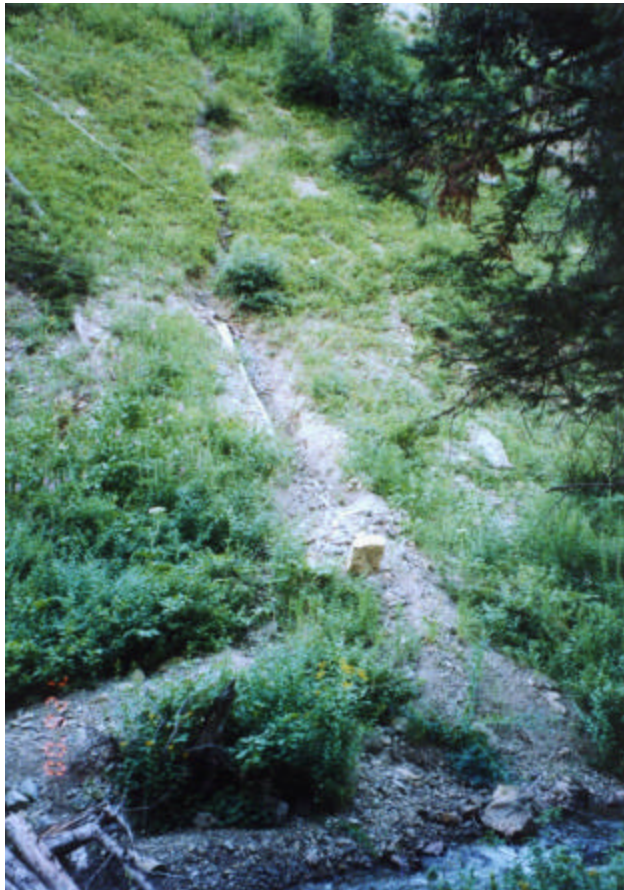
Stable dams could raise water level, trap sediment and slow stream velocities thereby reducing entrenchment and bank erosion caused by high flows. They could also help trap sediment from moving downstream. Substrates generally looked clean and unembedded. However, significant amounts of fines are entering Trail Creek from the closed Mail Cabin Creek road due to a stream capture and from several gully areas where water runs through culverts and down road fills associated with Wyoming State Road 22 making alluvial deposits into the stream (see photo).
